EZDown Instruction **EZDown Raptor Ford – ED0595**

FITTING CODE	MANUFACTURER	MODEL TYPE	YEAR	STOCKIST	PRODUCT	REVISION	LABOUR	DATE	PAGE
ED0590	FORD	RAPTOR	2011 onwards	GENERAL USE	EZDown	1	20min	20/07/2019	1
TORQUE – N.m	★ 25N.m ± 2N.m	★ 65N.m ± 2N.m		★ 17N.m ± 2N.m				www.ezdown.co.za

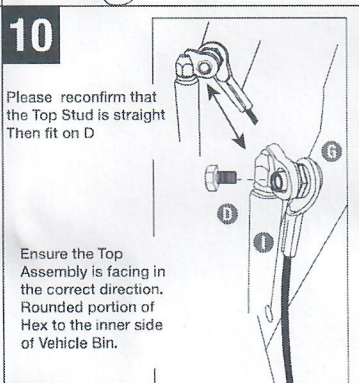
13

PLEASE ENSURE

Confirm that the Damper has some movement in the tailgate open position therefore ensuring the cables are taking the tailgate weight and not the damper.
